# **Internal Audit Department**

## **Interim Report 2011 – 5A**

**Disaster Recovery Initiative  
Property Review: 3404 Seminole Ave**

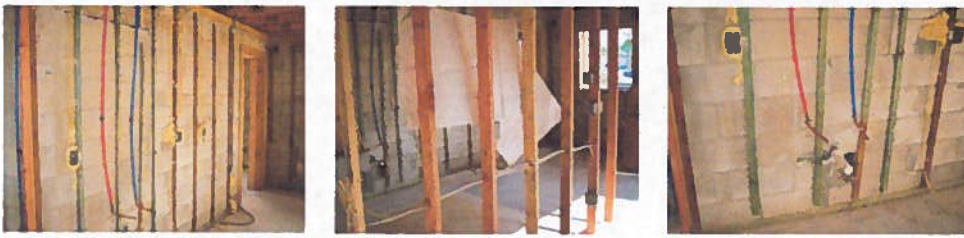
### c) Interior Framing \$1,800

- **Per bid specification #9:** Interior frame 14 walls per drawing per FBC. Walls can be framed with wood or metal framing. Install Deadwood in kitchen for cabinet install. In bathrooms for future grab bar install and towel bar & toilet paper install. In closet areas for shelving and closet rod install, and utility room for shelving install.
- **Per physical inspection:** Deadwood [support strips] not installed (kitchen area shown below). No permit inspection sign-off found for Framing even though work had been billed as complete.

- Contractors should be made clearly aware that billing for incomplete work can be construed as a fraudulent act and can put them in jeopardy of losing the ability to be awarded future jobs with the county, losing their contractor's license and/or criminal prosecution.
- Building inspections are required by law and therefore Project Managers should be aware of any sign-offs pending before work is considered completed by a Contractor. It is recommended that HHVS review the status of permit items is completed before payment requests are approved.
- Work must be completed prior to billing according to the bid specifications and the contract terms.

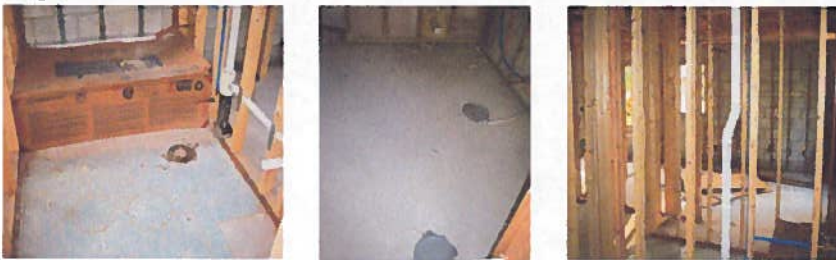
**d) Plumbing \$5,750**

- **Per bid specification #11:** The contractor's bid price shall reflect all plumbing installation to meet applicable codes. Plumbing hardware replacement: replace all plumbing hardware in 2 bathrooms, kitchen and utility room with new, mid-grade quality fixtures. Lavatory will have new pop up drain stop and shower will have new diverter valve, spout and shower head. Owner shall have choice of hardware with either single lever/flow type faucet or individual hot/cold handled hardware.
- **Per physical inspection:** No fixtures, faucets or other plumbing trim installed, not possible at this early stage of construction due to items such as cabinets and vanities not being installed yet.

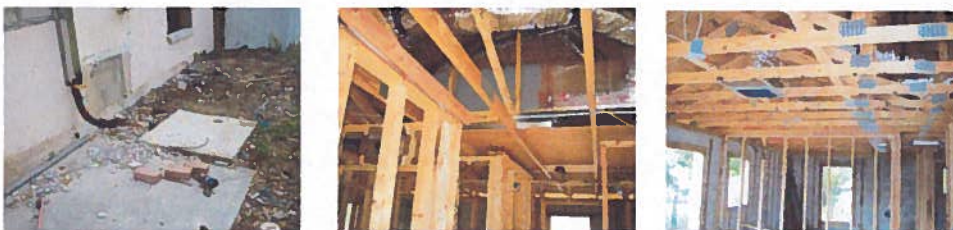
**e) HVAC \$3,800**

- **Per physical inspection:** A/C compressor, drains and trim not installed and not possible at this early stage of construction. No permit inspection sign-off found for Mechanical Rough A/C even though work had been billed as complete.

- **Per Contractor (7/6/2011):** Agreed that the compressor has not been installed yet.

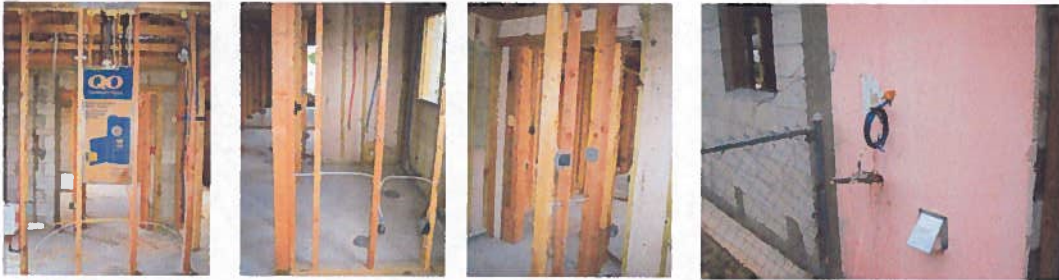
**f) Electrical and Low Voltage \$4,100**

- **Per physical inspection:** Switches, circuit breakers, outlets, interior, exterior lighting, bathroom light, exhaust fan, ceiling fans with light kits and smoke detectors not installed and not possible to complete at this early phase of construction. No permit inspection sign-off found for Electrical Rough or TV/Telephone Rough even though work had been billed as complete.
- **Per Contractor (7/6/2011):** Cannot pass the rough electrical inspection yet until the windows are installed; the Project Manager told the Contractor to stop work on the house so the windows are currently being stored with the vendor awaiting installation.
